**Flood Control Project Maintenance
Levee Inspections**

Maintenance Issue Types Only, Levee Inspection Report By Mile - Spring 2015

Reclamation District No. 0563 Tyler Island

Waterway	Bank	Unit Miles	Inspection Start/End	Inspector
Unit No. 01 Georgiana Slough (Tyler Island)	Left	12.11	04/07/2015 04/07/2015	Richard Willoughby

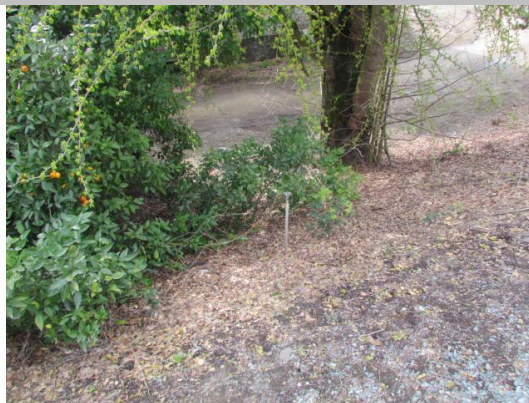
Photo 1 of 2 : SP_2015_RD0563_210_28_20150309_00032.jpg

Looking east at sprinklers on landside slope.

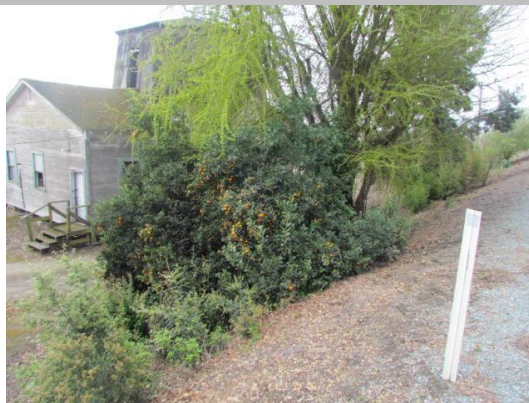
Photo 2 of 2 : SP_2015_RD0563_210_28_20150309_00033.jpg

Looking southeast at landscaping on landside slope and toe.

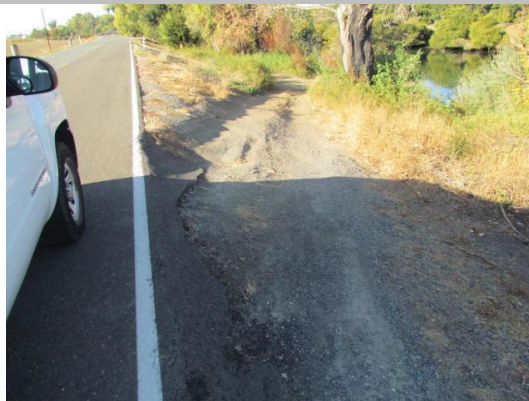
Photo 1 of 1 : SP_2015_RD0563_210_16_20150309_00020.jpg

LM Start	0.39	Rating **	M	Issue No.	16
LM End	0.39	Issue Type +	Ma	Location *	WS
Category	Earthen Levee			GPS Latitude/Longitude	
				Start	End
Item	Slope Stability			38.230841 °	38.230841 °
				-121.521898 °	-121.521898 °
DWR ID	DWR_RD0563_01_f_2013_16				
Action/Comments					
Repair the levee slope damaged by vehicle traffic and prevent access where possible.					
Inspector Comments: Slope damage is due to fishermen vehicle traffic.

Looking southwest at slope damage caused by vehicle traffic.

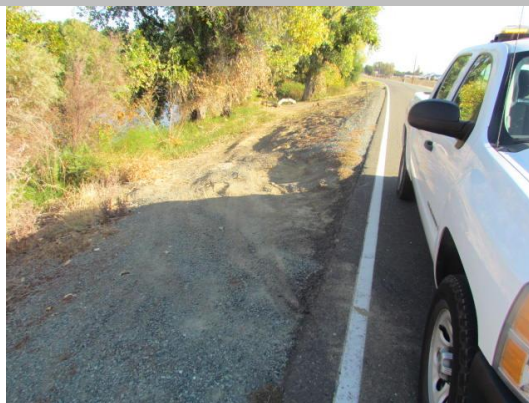
Photo 1 of 1 : SP_2015_RD0563_210_34_20150309_00036.jpg

LM Start	0.56	Rating **	M	Issue No.	34
LM End	0.56	Issue Type +	Ma	Location *	WS
Category	Earthen Levee			GPS Latitude/Longitude	
				Start	End
Item	Slope Stability			38.228948 °	38.228948 °
				-121.523904 °	-121.523904 °
DWR ID	DWR_RD0563_01_f_2013_34				
Action/Comments					
Repair the levee slope damaged by vehicle traffic and prevent access where possible.					
Inspector Comments: Slope damage is due to fishermen vehicle traffic.

Looking northwest at slope damage caused by vehicle traffic.

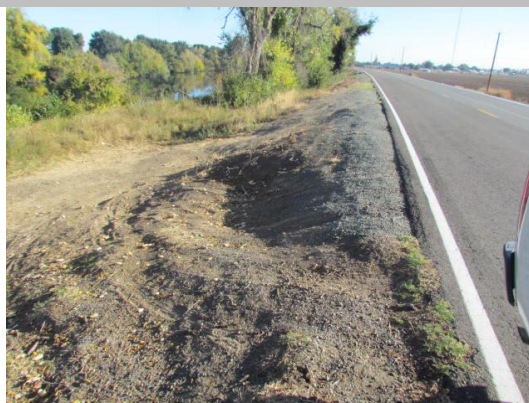
Photo 2 of 2 : SP_2015_RD0563_210_143_20150309_00129.jpg

Looking northwest at slope damage on waterward slope.

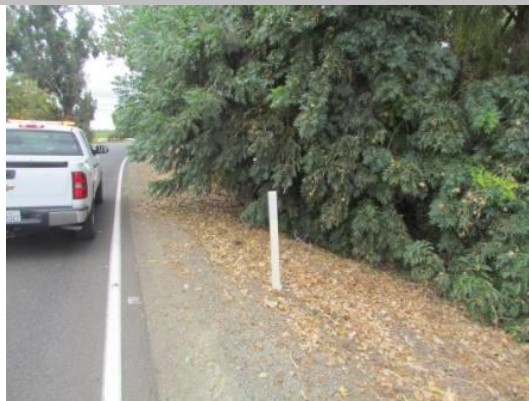
Photo 2 of 2 : SP_2015_RD0563_210_3_20150309_00002.jpg

Looking southwest at overgrown trees on waterside slope.

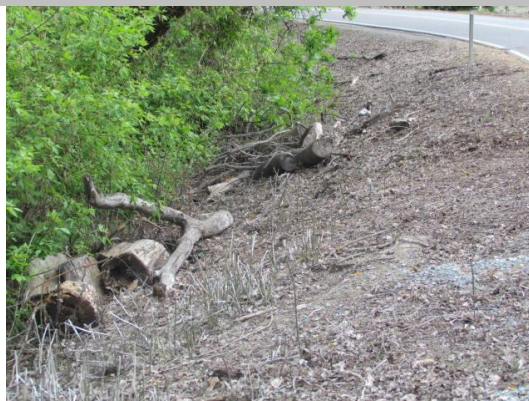
Photo 1 of 2 : SP_2015_RD0563_210_9_20150309_00010.jpg

LM Start	0.84	Rating **	M	Issue No.	9
LM End	0.84	Issue Type +	Ma	Location *	WS
Category	Earthen Levee			GPS Latitude/Longitude	
				Start	End
Item	Encroachments			38.225685 °	38.225685 °
				-121.526288 °	-121.526288 °
DWR ID	DWR_RD0563_01_s _ 2012_9				
Action/Comments					
Prunings					
Inspector Comments: Prunings on waterside slope should be burned or removed.

Looking northeast at tree limbs on waterward slope.

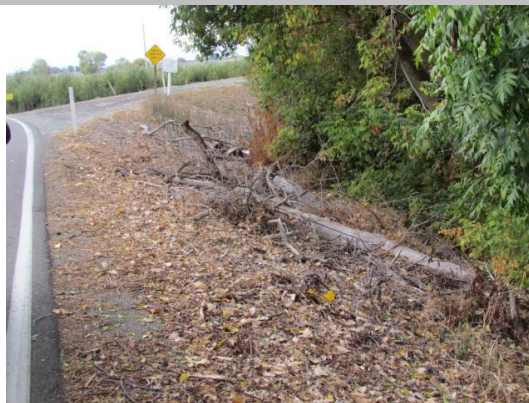
Photo 2 of 2 : SP_2015_RD0563_210_9_20150309_00011.jpg

LM Start	0.84	Rating **	M	Issue No.	9 (cont)	
LM End	0.84	Issue Type +	Ma	Location *	WS	
Category	Earthen Levee			GPS Latitude/Longitude		
				Start		End
Item	Encroachments			38.225685 °	38.225685 °	
				-121.526288 °	-121.526288 °	
DWR ID	DWR_RD0563_01_s_2012_9					
Action/Comments						
Prunings						
Inspector Comments: Prunings on waterside slope should be burned or removed.

Looking southwest at tree limbs on waterside slope.

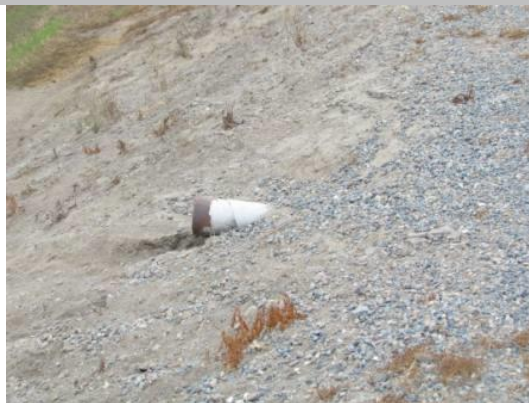
Photo 1 of 2 : SP_2015_RD0563_210_937_20150309_00135.jpg

Looking southwest at abandoned pipe on landside slope.

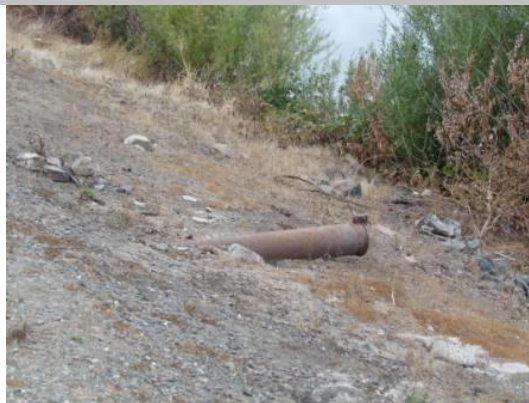
Photo 2 of 2 : SP_2015_RD0563_210_937_20150309_00136.jpg

Looking southwest at pipe on waterside slope.

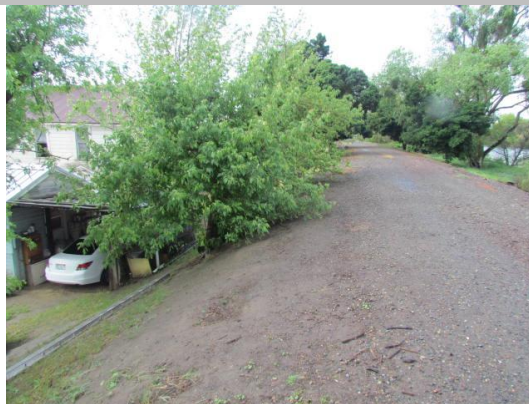
Photo 1 of 1 : SP_2015_RD0563_210_5_20150409_00969.jpg

Looking south at untrimmed trees on landward slope.

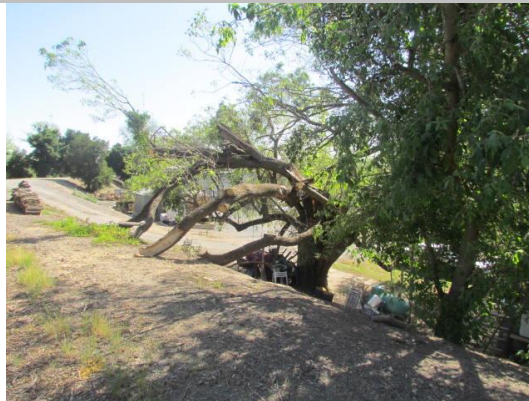
Photo 1 of 1 : SP_2015_RD0563_210_103_20150309_00118.jpg

LM Start	1.25	Rating **	A/W	Issue No.	103
LM End	1.25	Issue Type +	Ma	Location *	LS
Category	Earthen Levee			GPS Latitude/Longitude	
				Start	End
Item	Encroachments				°
					°
DWR ID	DWR_RD0563_01_s_2013_103				
Action/Comments					
Tree or limb					
Inspector Comments: Broken tree branches on landward slope.

Looking northeast at broken tree branch on landward slope.

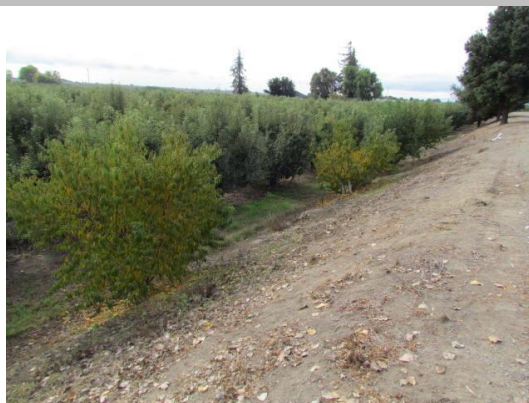
Photo 1 of 1 : SP_2015_RD0563_210_64_20150309_00070.jpg

LM Start	1.27	Rating **	M	Issue No.	64
LM End	1.27	Issue Type +	Ma	Location *	LS
Category	Earthen Levee			GPS Latitude/Longitude	
				Start	End
Item	Trim / Thin Trees			38.225730 °	38.225730 °
				-121.532824 °	-121.532824 °
DWR ID	DWR_RD0563_01_f_2012_64				
Action/Comments					
Trim trees to at least five feet above ground level.					
Inspector Comments: Trees located at landside toe.

Looking southeast at fruit trees on landside toe.

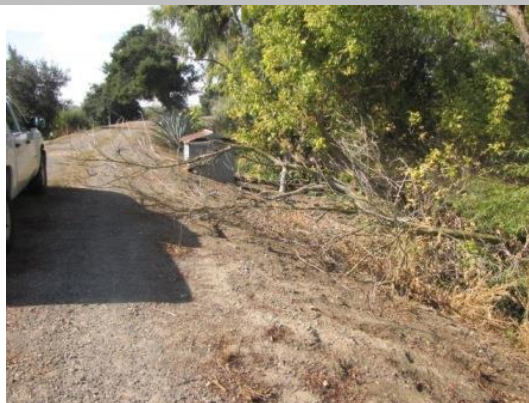
Photo 1 of 1 : SP_2015_RD0563_210_19_20150309_00024.jpg

LM Start	1.39	Rating **	A/W	Issue No.	19
LM End	1.39	Issue Type +	Ma	Location *	WS
Category	Earthen Levee			GPS Latitude/Longitude	
				Start	End
Item	Encroachments			38.224367 °	38.224367 °
				-121.534165 °	-121.534165 °
DWR ID	DWR_RD0563_01_s_2012_19				
Action/Comments					
Tree or limb					
Inspector Comments: Broken tree along waterside slope.

Looking south at a downed tree on waterside slope.

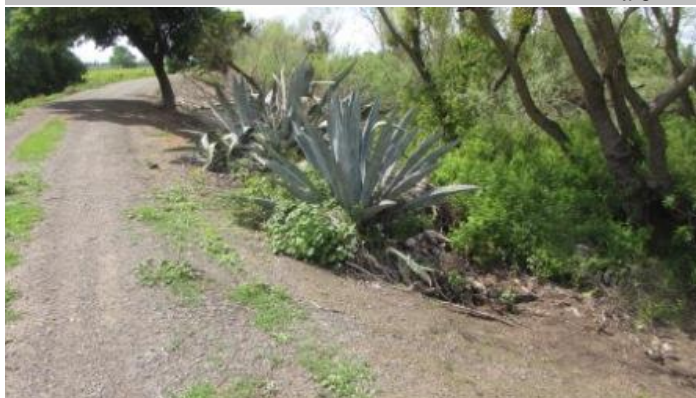
Photo 1 of 2 : SP_2015_RD0563_210_6_20150309_00005.jpg

Updated view looking upstream at a century plant on waterside shoulder slope.

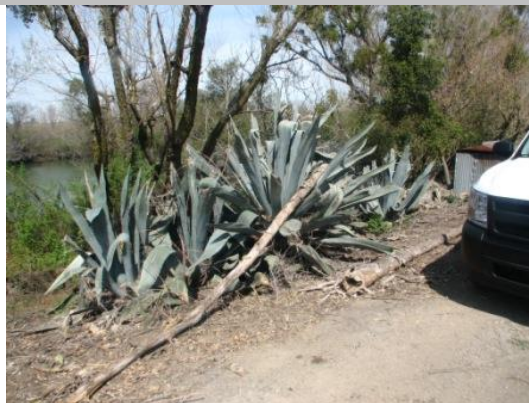
Photo 2 of 2 : SP_2015_RD0563_210_6_20150309_00006.jpg

Century plant on waterward shoulder at LM 1.42

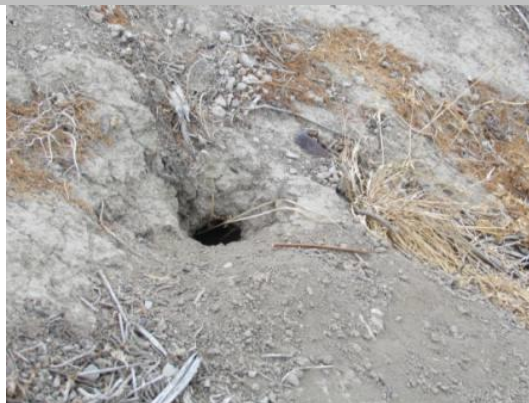
Photo 1 of 1 : SP_2015_RD0563_210_83_20150309_00092.jpg

Looking west at rodent hole on landside slope.

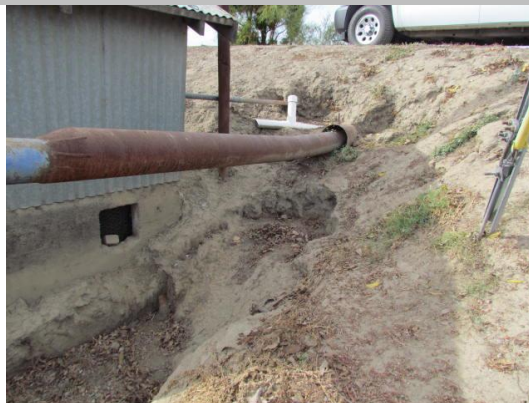
Photo 1 of 2 : SP_2015_RD0563_210_71_20150309_00074.jpg

Looking west at erosion at landside toe and slope next to pump house.

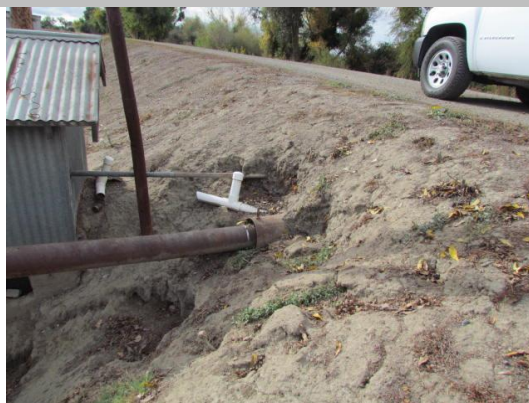
Photo 2 of 2 : SP_2015_RD0563_210_71_20150309_00075.jpg

Looking southwest at erosion around irrigation pipe on landside slope and toe.

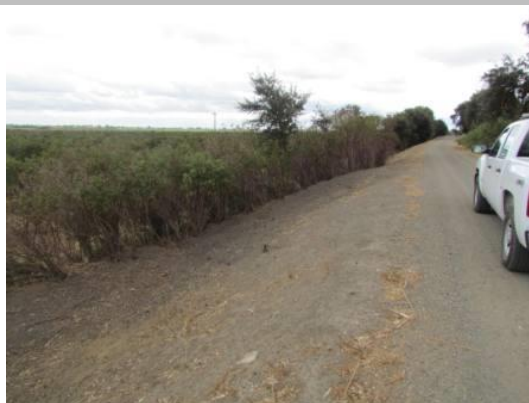
Photo 1 of 2 : SP_2015_RD0563_210_11_20150309_00015.jpg

Look southeast at updated (10/11) view of elderberries on landside slope.

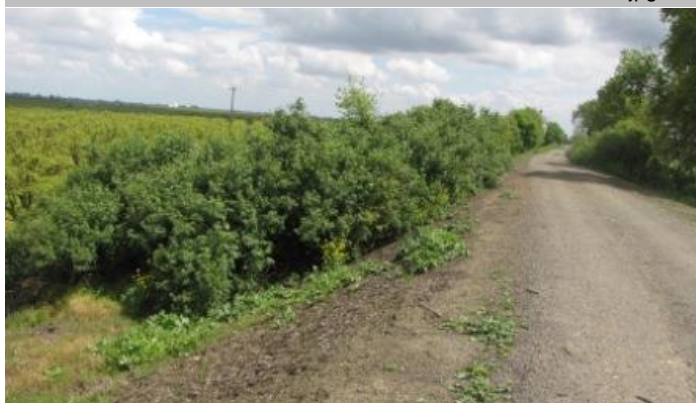
Photo 2 of 2 : SP_2015_RD0563_210_11_20150309_00016.jpg

Looking southeast at elderberry on the landside slope and toe.

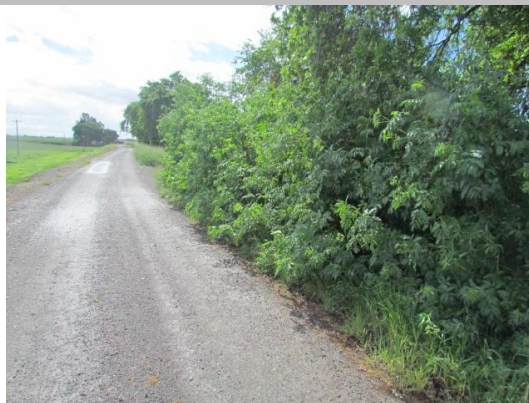
Photo 1 of 2 : SP_2015_RD0563_210_12_20150409_00972.jpg

Looking south at dense elderberry on waterward shoulder and slope.
(Spring 2015)

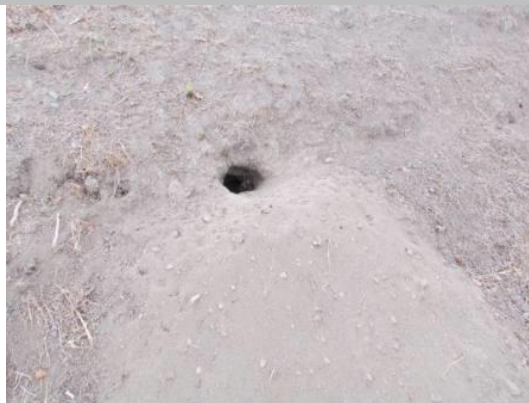
Photo 1 of 4 : SP_2015_RD0563_210_85_20150309_00095.jpg

Looking west at rodent hole on landside slope.

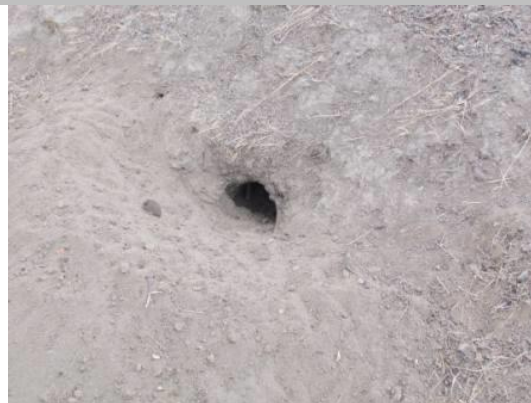
Photo 2 of 4 : SP_2015_RD0563_210_85_20150309_00096.jpg

Looking east at rodent hole on landside slope.

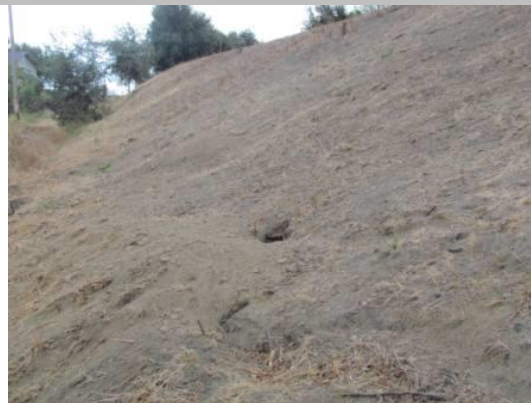
Photo 3 of 4 : SP_2015_RD0563_210_85_20150309_00097.jpg

Looking southwest at rodent holes on landside slope.

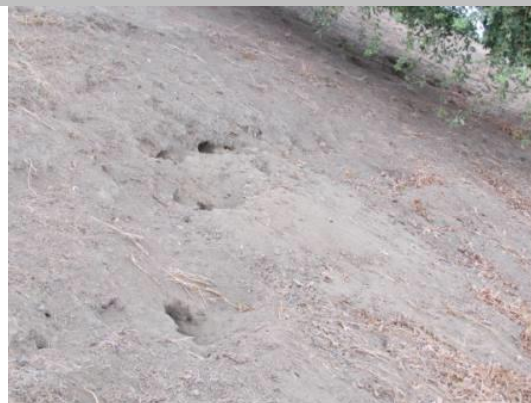
Photo 4 of 4 : SP_2015_RD0563_210_85_20150309_00098.jpg

Looking northeast at rodent holes on landside slope.

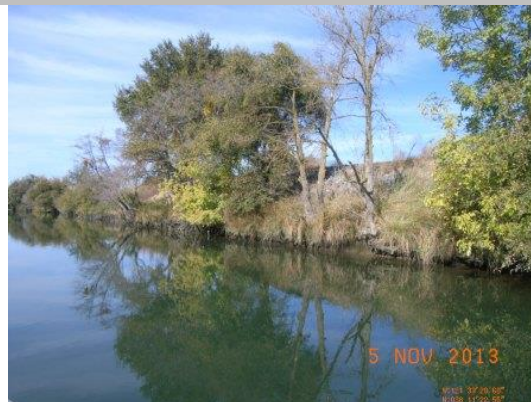
Photo 1 of 1 : SP_2015_RD0563_210_53_20150309_00051.jpg

LM Start	2.61	Rating **	M	Issue No.	53
LM End	2.82	Issue Type +	Ma	Location *	WS
Category	Supplemental			GPS Latitude/Longitude	
				Start	End
Item	USACE Erosion Survey			38.214133 °	38.211737 °
				-121.537778 °	-121.535436 °
DWR ID	DWR_RD0563_01_f _ 2014_53				
Action/Comments					
Inspector Comments: 1997 - Loss of rock at toe; pockets of upper berm erosion; very narrow berm width; toe rock problem; erosion pockets in rock. 2002 - New brush boxes at toe of the worst spots. 2005 - Upstream 200 ft removed because of the wide berm. 2006 - Some rock repair pockets behind the brush boxes at the upstream end. 2010 - Some new erosion. 2013: New rock placed on the levee slope. [2013 Site ID: GEO_9-3_L]

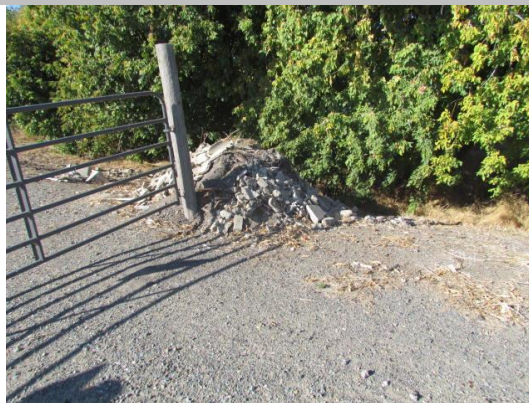
Photo 1 of 2 : SP_2015_RD0563_210_104_20150309_00119.jpg

LM Start	2.89	Rating **	M	Issue No.	104
LM End	2.89	Issue Type +	Ma	Location *	LS
Category	Earthen Levee			GPS Latitude/Longitude	
				Start	End
Item	Encroachments			38.210966 °	38.210966 °
				-121.534813 °	-121.534813 °
DWR ID	DWR_RD0563_01_f_2013_104				
Action/Comments					
Material Inspector Comments: Landowner stockpiled concrete rubble on landward and waterward slope to stop trespassers. Landowner should replace the stockpile with a proper fence.

Looking west at concrete rubble on waterward shoulder and slope.

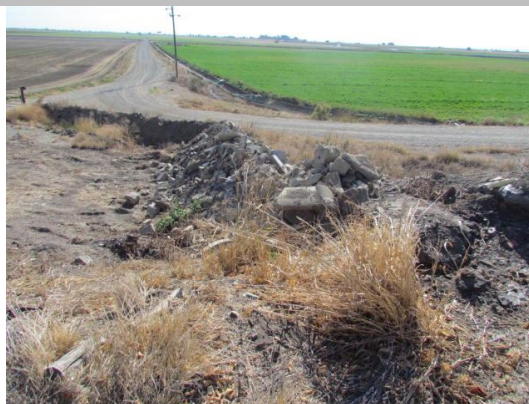
Photo 2 of 2 : SP_2015_RD0563_210_104_20150309_00120.jpg

Looking east at concrete rubble on landward slope.

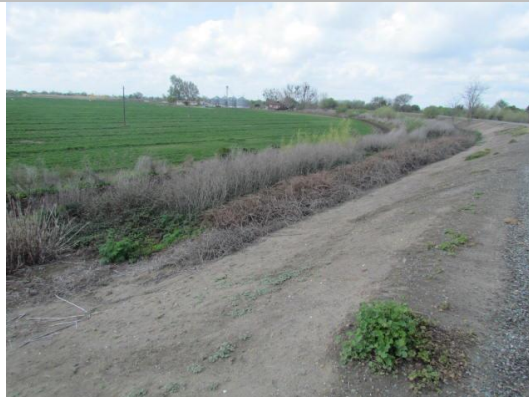
Photo 2 of 3 : SP_2015_RD0563_210_74_20150309_00078.jpg

Looking southeast at dead berryvine on landside toe. (Fall 2014)

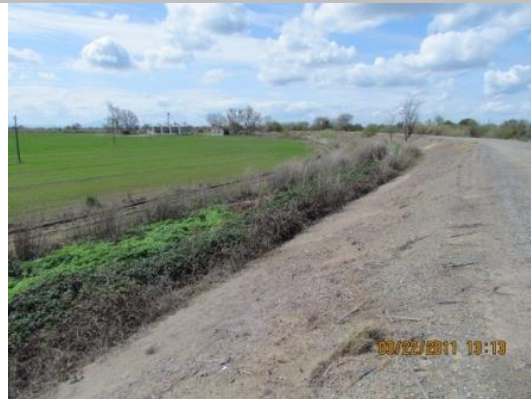
Photo 3 of 3 : SP_2015_RD0563_210_74_20150309_00079.jpg

Looking southeast at berryvines on landside toe. (Fall 2014)

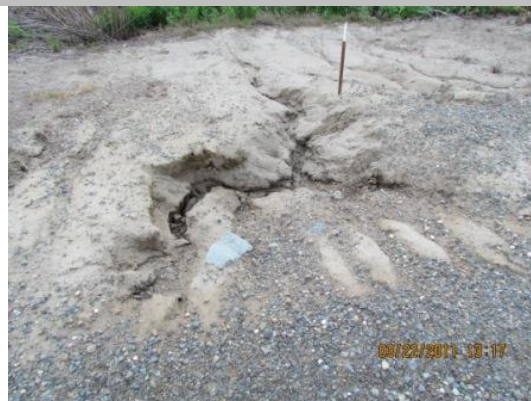
Photo 1 of 4 : SP_2015_RD0563_210_78_20150309_00085.jpg

LM Start	3.06	Rating **	M	Issue No.	78
LM End	3.06	Issue Type +	Ma	Location *	LS
Category	Earthen Levee			GPS Latitude/Longitude	
				Start	End
Item	Slope Stability			38.210240 °	38.210240 °
				-121.537517 °	-121.537517 °
DWR ID	DWR_RD0563_01_s_2012_78				
Action/Comments					
Repair slope instability.					
Inspector Comments: Slope damage on landward shoulder and slope.

Looking east at slope erosion cause by runoff on landside slope.

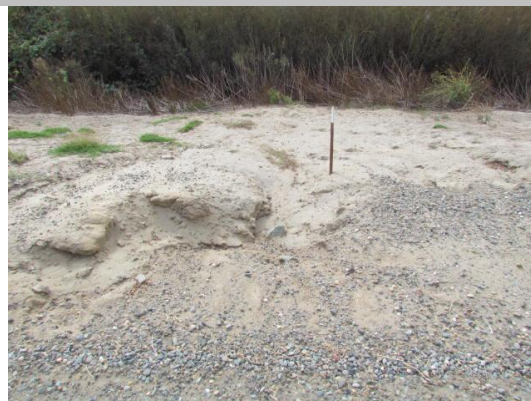
Photo 2 of 4 : SP_2015_RD0563_210_78_20150309_00086.jpg

Looking east at slope damage on 10/31/2012, no change in status.

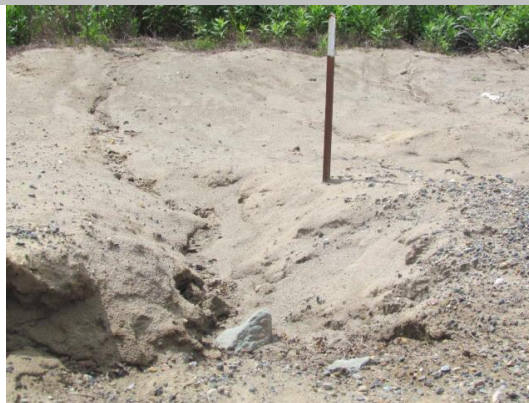
Photo 3 of 4 : SP_2015_RD0563_210_78_20150309_00087.jpg

LM Start	3.06	Rating **	M	Issue No.	78 (cont)
LM End	3.06	Issue Type +	Ma	Location *	LS
Category	Earthen Levee			GPS Latitude/Longitude	
				Start	End
Item	Slope Stability			38.210240 °	38.210240 °
				-121.537517 °	-121.537517 °
DWR ID	DWR_RD0563_01_s _ 2012_78				
Action/Comments					
Repair slope instability.					
Inspector Comments: Slope damage on landward shoulder and slope.

Looking east at slope erosion. (Updated Spring 2012)

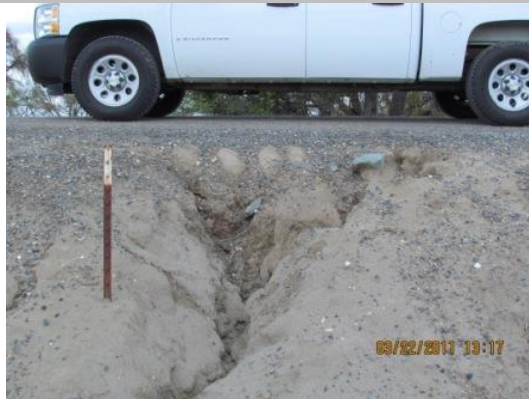
Photo 4 of 4 : SP_2015_RD0563_210_78_20150309_00088.jpg

Looking west at slope erosion cause by runoff on landside slope.

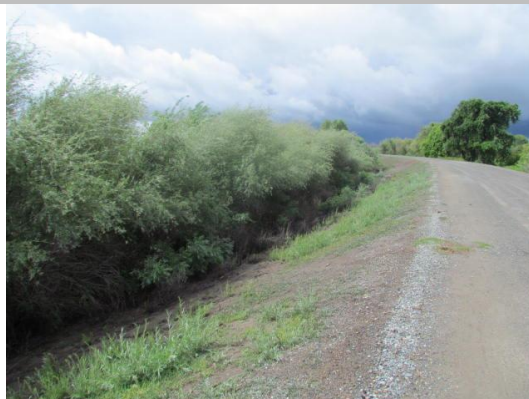
Photo 1 of 1 : SP_2015_RD0563_210_763_20150409_00975.jpg

Looking south at dense vegetation at landward slope and toe. (Spring 2015)

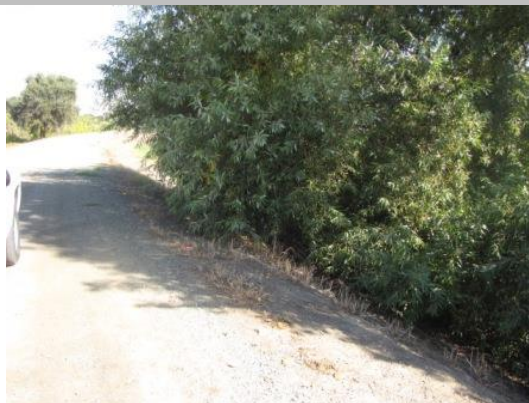
Photo 2 of 2 : SP_2015_RD0563_210_68_20150309_00072.jpg

Looking southeast at dense trees on landside slope and toe.

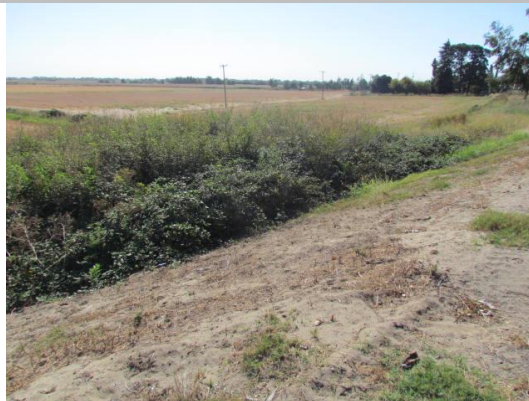
Photo 2 of 2 : SP_2015_RD0563_210_84_20150309_00094.jpg

Looking southeast at dense berryvines on landward toe.

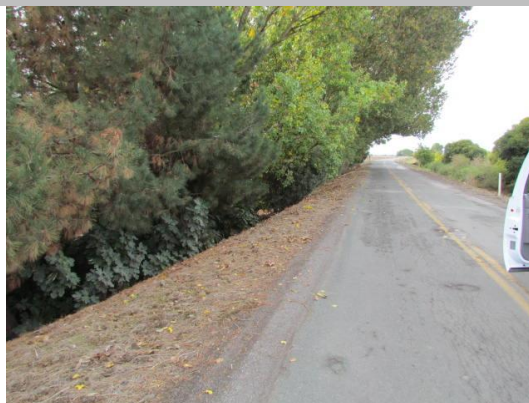
Photo 1 of 1 : SP_2015_RD0563_210_88_20150309_00101.jpg

Looking south at dense trees on landside slope and toe.

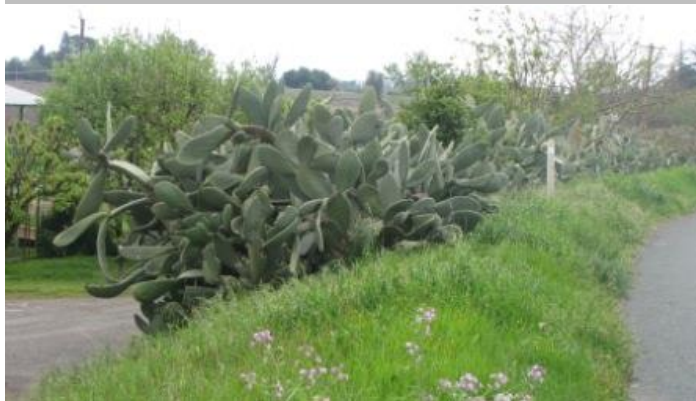
Photo 1 of 2 : SP_2015_RD0563_210_22_20150309_00025.jpg

Looking at north end of cactus on the landside slope.

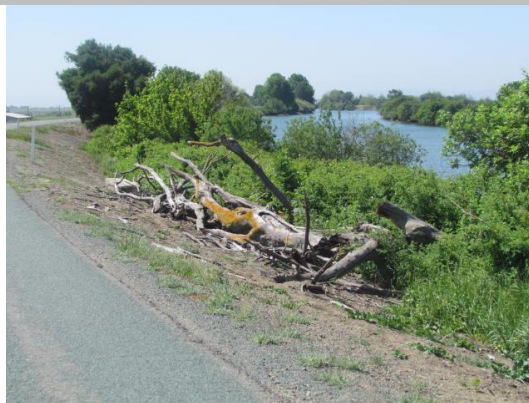
Photo 1 of 1 : SP_2015_RD0563_210_95_20150309_00111.jpg

Looking southwest at prunings on waterward slope.

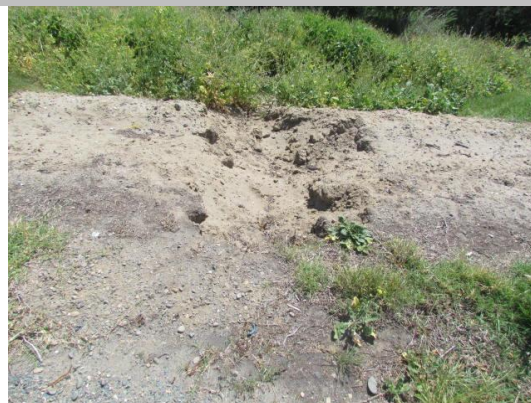
Photo 1 of 1 : SP_2015_RD0563_210_97_20150309_00113.jpg

Looking east at slope erosion on landward shoulder and slope.

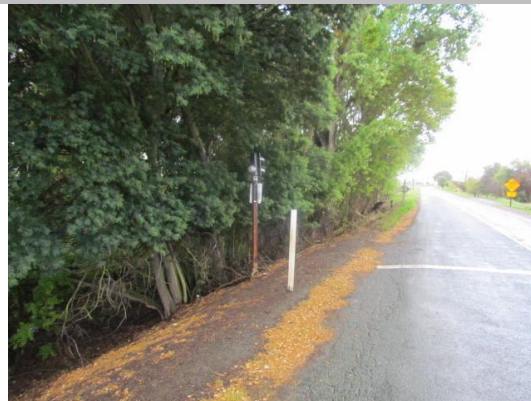
Photo 1 of 1 : SP_2015_RD0563_210_29_20150409_00979.jpg

Looking southeast at dense trees on landward slope and toe.

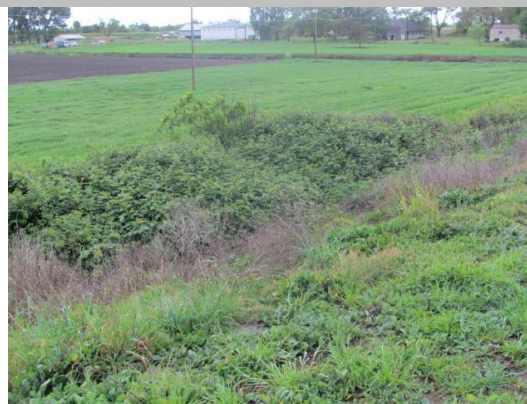
Photo 1 of 1 : SP_2015_RD0563_210_767_20150409_00981.jpg

Looking east at dense wild vines at landward toe.

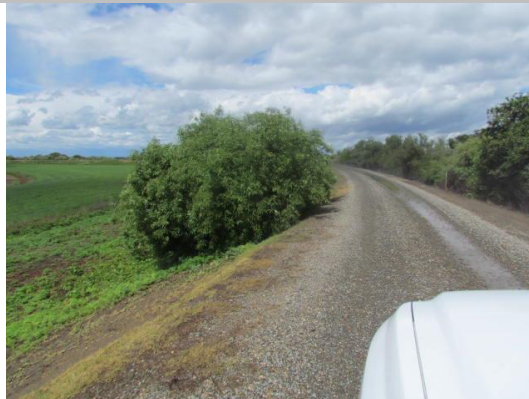
Photo 1 of 1 : SP_2015_RD0563_210_36_20150409_00986.jpg

Looking south at elderberry on landward slope.

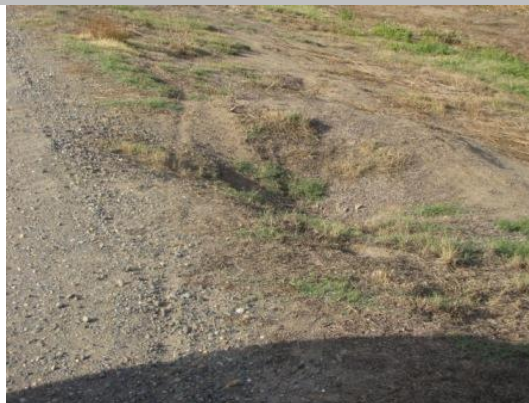
Photo 1 of 4 : SP_2015_RD0563_210_76_20150309_00080.jpg

Looking northeast a depression on landside shoulder and slope above 10" irrigation pipe four feet below crown.

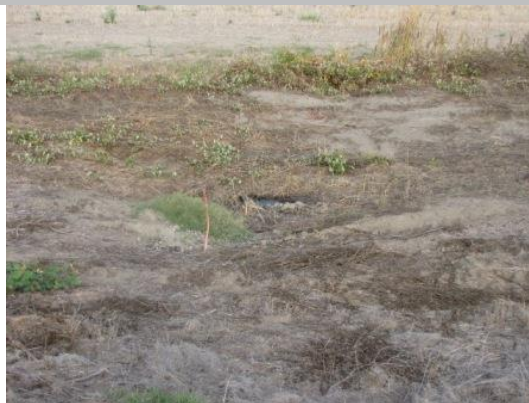
Photo 2 of 4 : SP_2015_RD0563_210_76_20150309_00081.jpg

Looking east at water ponding at landside toe just above 10" irrigation pipe.

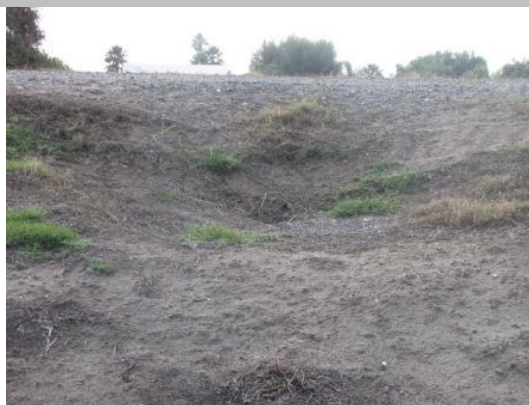
Photo 3 of 4 : SP_2015_RD0563_210_76_20150309_00082.jpg

Looking west at depression on landside shoulder and slope from landside toe.

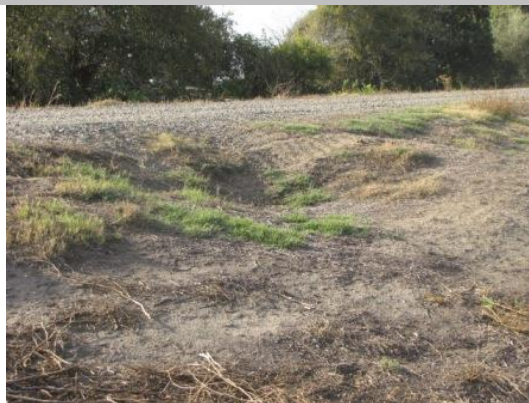
Photo 4 of 4 : SP_2015_RD0563_210_76_20150309_00083.jpg

Looking west at depression on landside shoulder and slope.

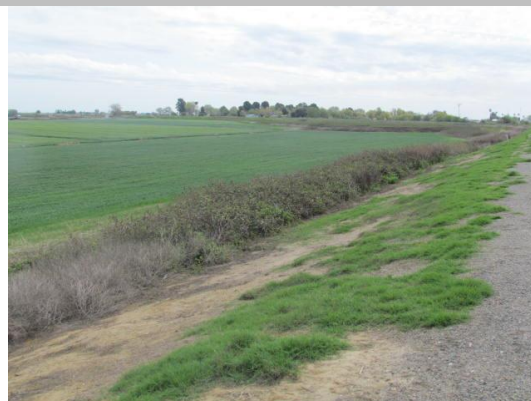
Photo 2 of 3 : SP_2015_RD0563_210_100_20150309_00117.jpg

Looking south at dense vegetation at landward toe. (Fall 2014)

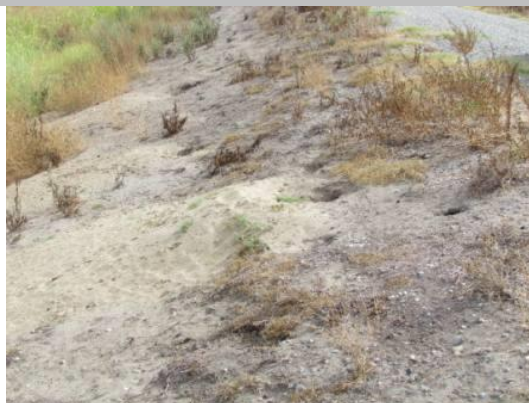
Photo 3 of 3 : SP_2015_RD0563_210_91_20150309_00109.jpg

Looking south at rodent holes on landside slope.

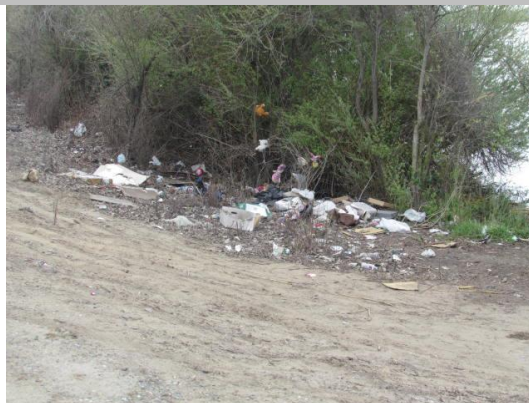
Photo 1 of 1 : SP_2015_RD0563_210_107_20150309_00121.jpg

Looking southwest at garbage at waterward slope and toe.

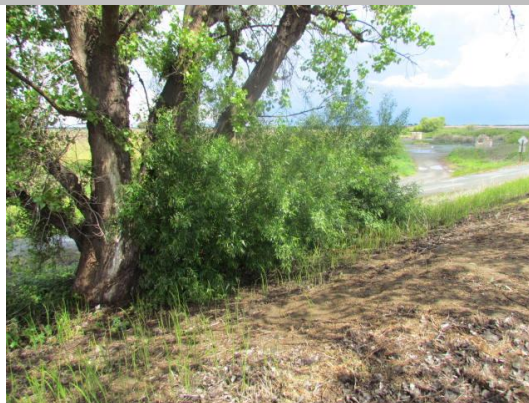
Photo 1 of 1 : SP_2015_RD0563_210_47_20150409_00989.jpg

Looking east at untrimmed tree at landward slope. (Spring 2015)
